**CWA RECONNAISSANCE INSPECTION REPORT
U.S. ENVIRONMENTAL PROTECTION AGENCY, REGION 5**

Purpose: Compliance Evaluation Reconnaissance Inspection

Facility: Breese Site Hog Farm
19722 Low Bridge Road
Breese, Illinois 62230

Date of Inspection: October 25, 2010

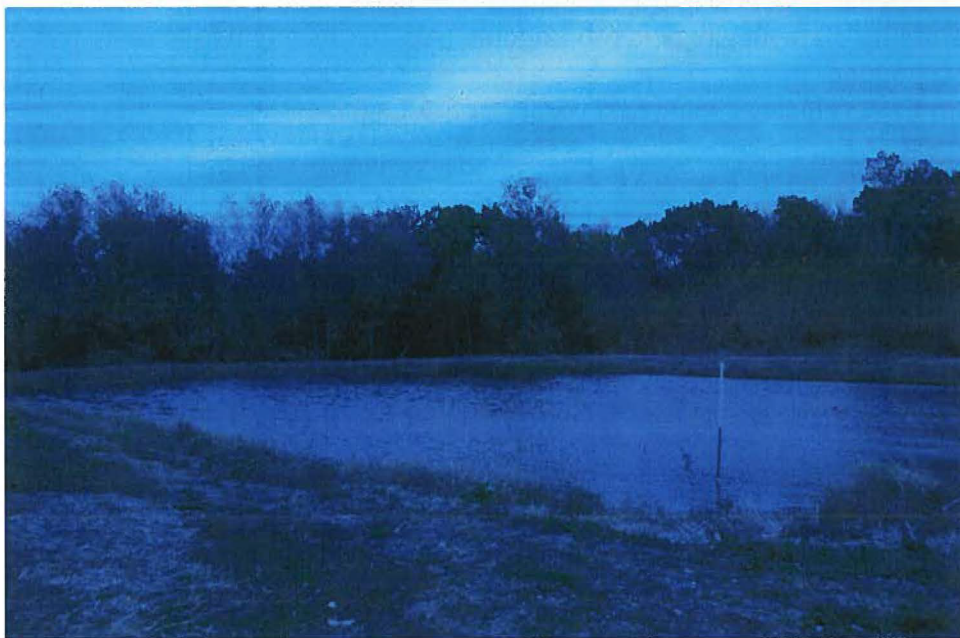
EPA drove down the driveway toward Barns #5 and #6. The 5-6 Lagoon behind Barn #6 had been pumped down and a depth gauge installed. EPA did not exit the vehicle and therefore was not able to view the northeast corner of Barn #6 where previously there had been manure discharging. EPA estimated that there was approximately two to three feet of freeboard in the 5-6 Lagoon.

DSC_7536: 5-6 Lagoon has been pumped down and depth gauge installed.

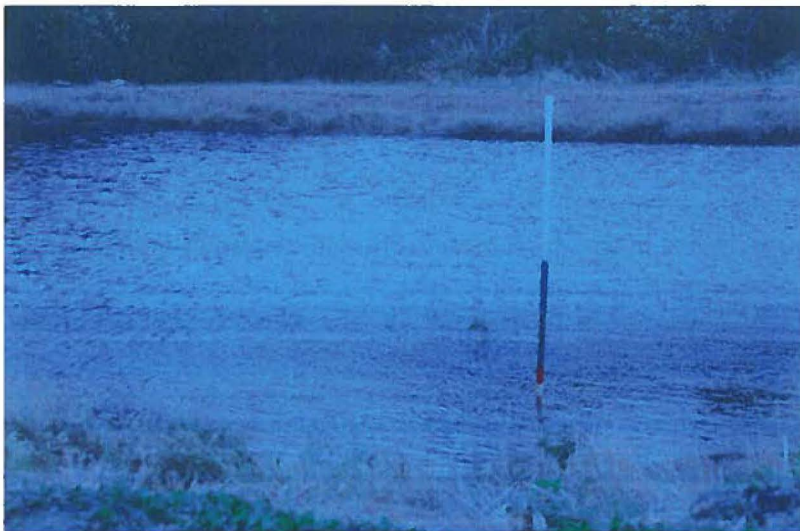
DSC_7537: Close up of depth gauge in 5-6 Lagoon. Approximately two to three feet of freeboard in 5-6 Lagoon.

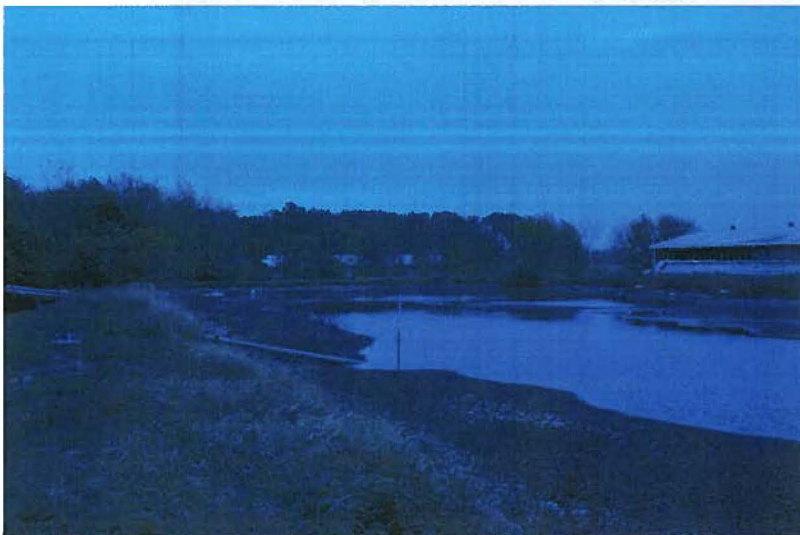
EPA then drove to the driveway that led to the Complex Lagoon behind Barn #1. Again, the pond had been pumped down and a depth gauge installed. EPA estimated that the pond had approximately two to three feet of freeboard.

DSC_7540: Complex Lagoon has been pumped down. EPA estimated that there is approximately two to three feet of freeboard in Complex Lagoon. Depth gauge is installed.

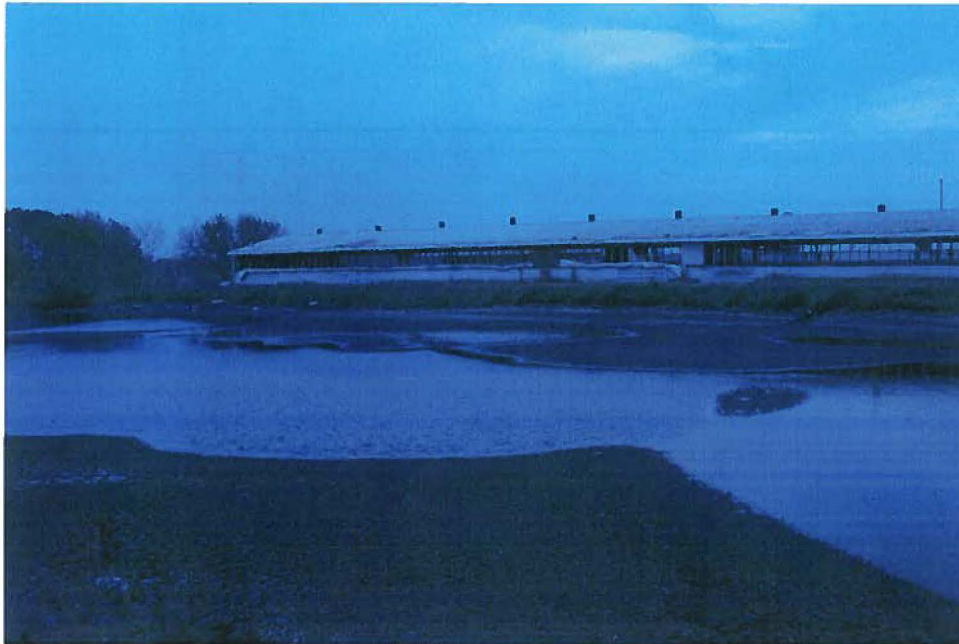
DSC_7541: Complex Lagoon has been pumped down.
Location: Northwest corner of Complex Lagoon.
Facing: Southeast
Date/Time: October 25, 2010 4:48 P.M.

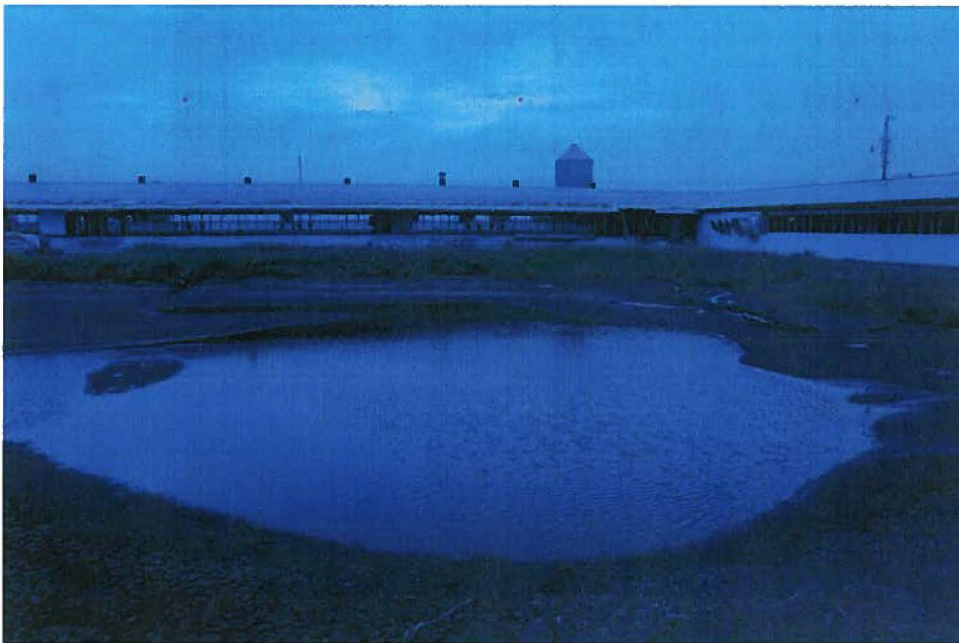
DSC_7542: Complex Lagoon has been pumped down.
Location: Northwest corner of Complex Lagoon.
Facing: South
Date/Time: October 25, 2010 4:48 P.M.

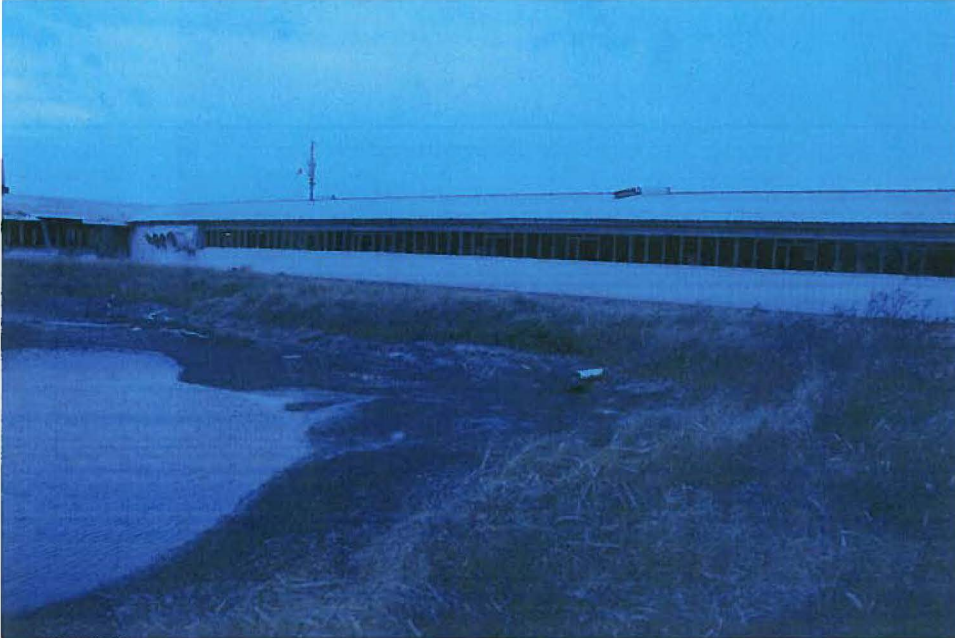
DSC_7543: Complex Lagoon has been pumped down.
Location: Northwest corner of Complex Lagoon.
Facing: Southwest
Date/Time: October 25, 2010 4:48 P.M.

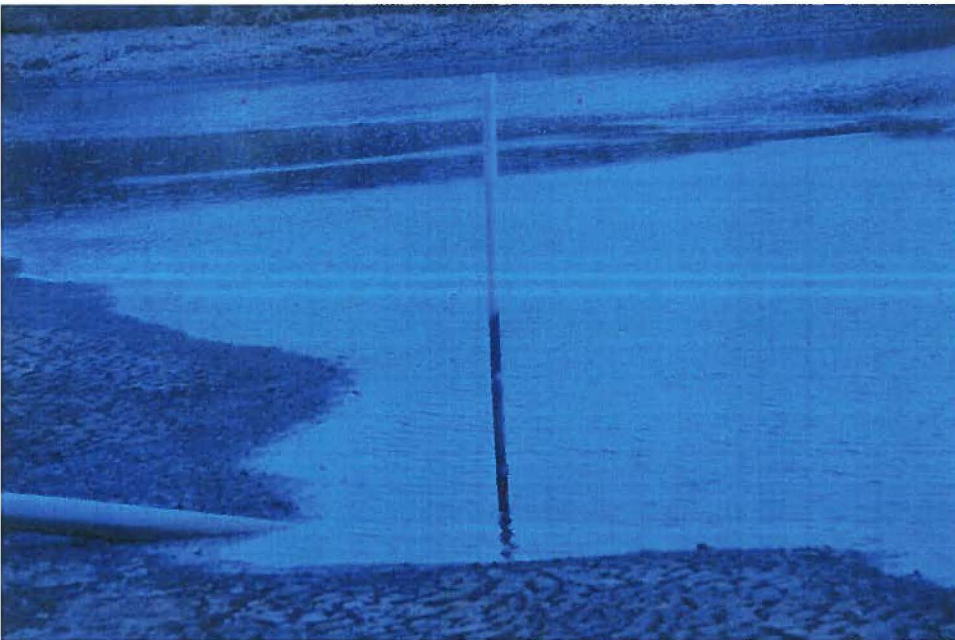
DSC_7544: Close up of depth gauge in Complex Lagoon.
Location: Northwest corner of Complex Lagoon.
Facing: East
Date/Time: October 25, 2010 4:48 P.M.

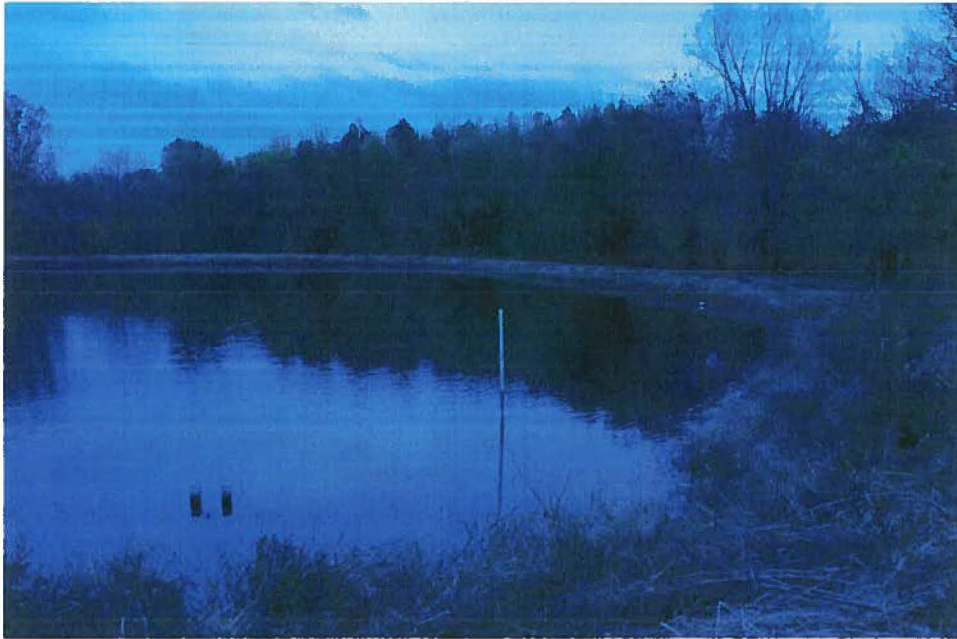
Previous discharges in this section of the facility included discharges from the southwest corner of the West North Lagoon and the southeast side of the East North Lagoon. On the date of this reconnaissance inspection, the ponds had been pumped down and a depth gauge installed in the West North Lagoon. EPA estimated there to be approximately three feet of freeboard. A previous water main break on the west side of Barn #7 had been repaired, and the failed roof over Barn #7 had been covered to prevent storm water from accessing the underground pit and then flowing to the pond system.

DSC_7545: West North Lagoon has been pumped down and a depth gauge installed.

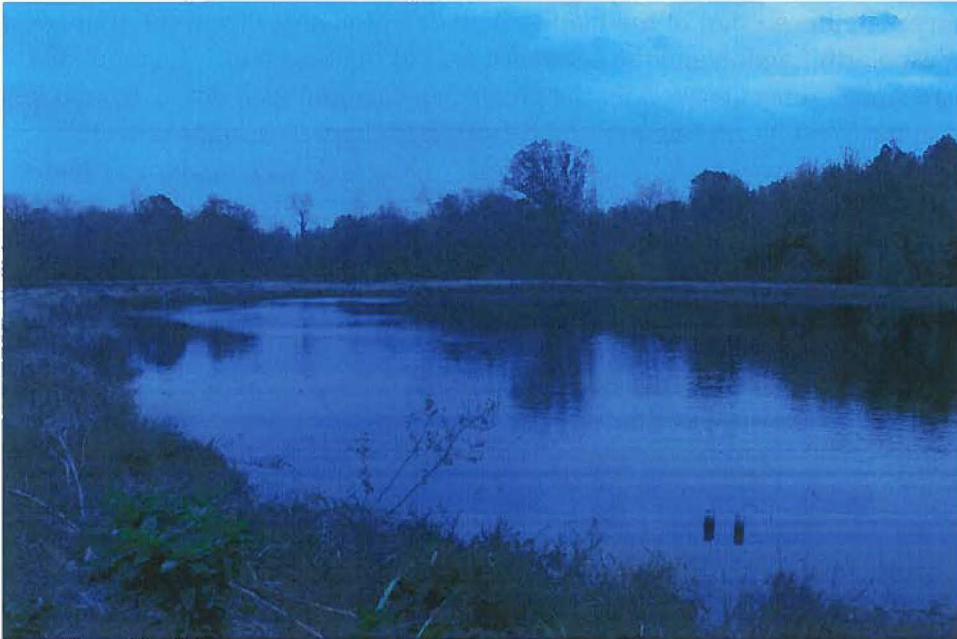
DSC_7546: West North Lagoon in foreground and East North Lagoon in background.
Location: Northwest corner of West North Lagoon.
Facing: East
Date/Time: October 25, 2010 4:55 P.M.
